STORMWATER MANAGEMENT/BMP INSPECTION CHECKLIST

Inspection Date: January 14, 2016

Site Address or Location: 3871 Mountain Shade Drive, Marshall, VA 20115

MOUNTAIN SHADE SUBDIVISION
Stormwater Management Pond Inspection

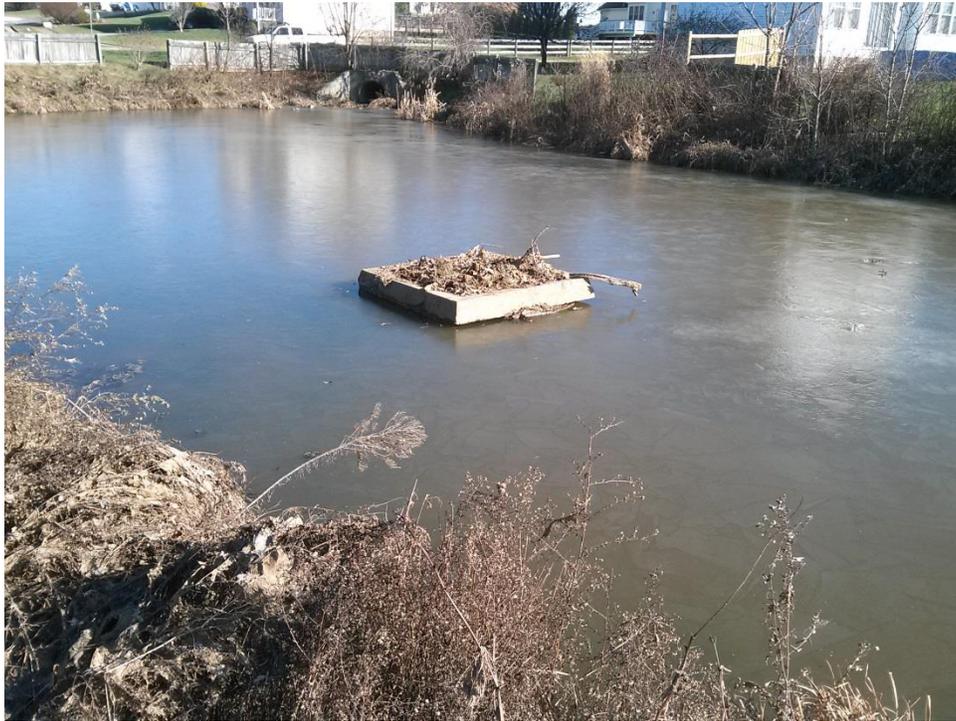
Item Inspected	Checked		Observations and Remarks
	Yes	No	
Is the culvert or storm drain filled more than 25% with debris, sediment, or trash?	<input checked="" type="checkbox"/>	<input type="checkbox"/>	The primary spillway is completely blocked. See photo.
Is there evidence of structural failure of the culvert pipe?	<input type="checkbox"/>	<input checked="" type="checkbox"/>	
Is there evidence of erosion at the inlet and outlet of the culvert or at the storm drain inlet?	<input type="checkbox"/>	<input checked="" type="checkbox"/>	
Are there signs of settling, cracking, or misalignment of culverts, storm drain pipe, or concrete inlets?	<input type="checkbox"/>	<input checked="" type="checkbox"/>	
Is the emergency spillway clear of obstructions, debris, and vegetation?	<input checked="" type="checkbox"/>	<input type="checkbox"/>	Please note previous comments regarding failure.
Is the outlet structure and pipe clean of debris and sediment, free of damage, and in working order?	<input type="checkbox"/>	<input checked="" type="checkbox"/>	Primary spillway is completely blocked.

Principal spillway riser completely obstructed by debris

The principal spillway is completely block by debris. All debris needs to be removed. The emergency spillway has failed, resulting in sever erosion in a significant portion of the spillway. The filter fabric in the spillway has been ripped away, and much of the riprap from the failure area is now in the outlet channel. Please see attached photographs. The emergency spillway must be repaired, including backfilling and compacting the eroded portion of the spillway; restoration of the filter fabric on the backfilled area; and, replacement of the riprap. The riprap must be removed from the stream channel.

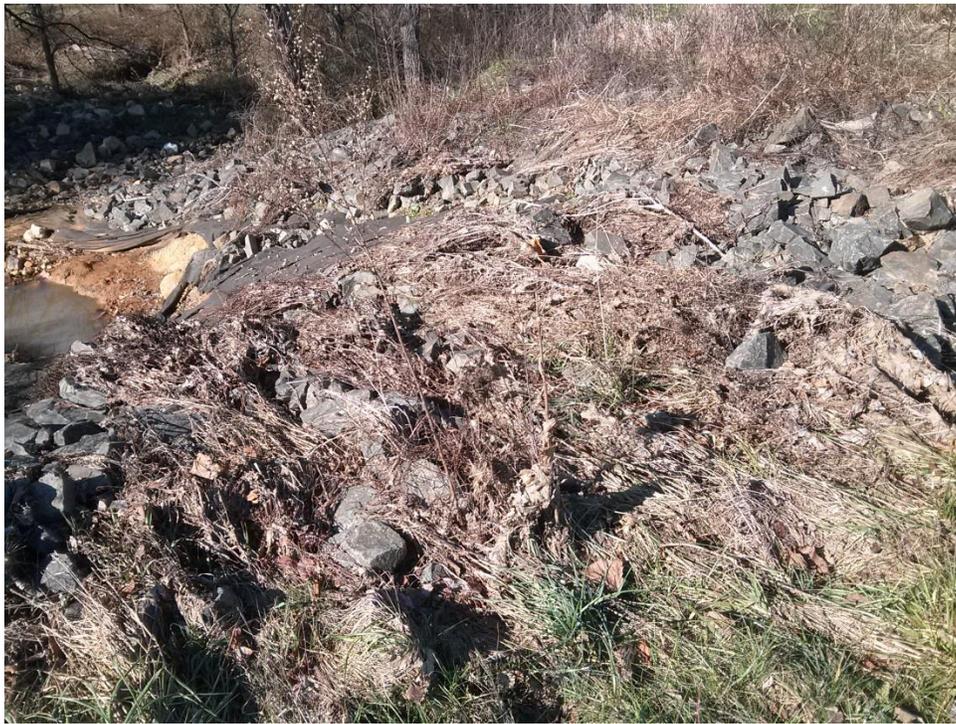
Emergency spillway from top of dam

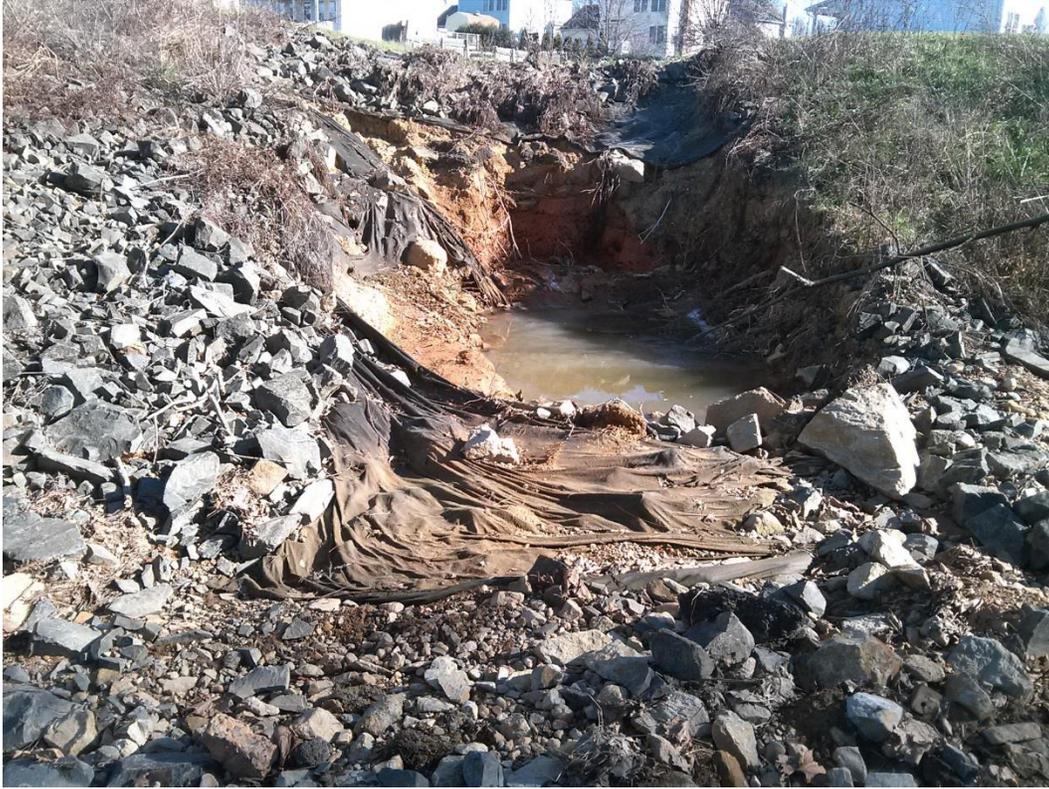
Emergency spillway from toe of embankment

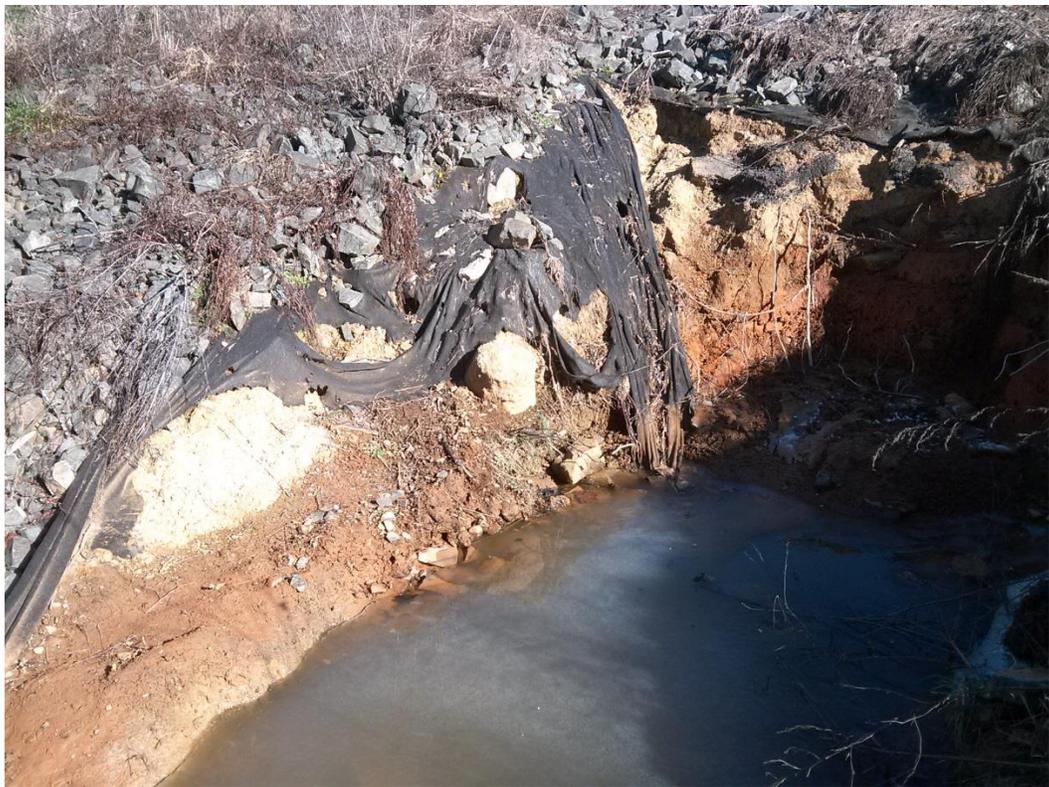
Close up view of emergency spillway failure

Recommendations - Consult with a geotechnical engineer to ensure that emergency spillway repairs are done properly and in such a manner that would prevent future failure. At a minimum, riprap in the emergency spillway should be grouted.

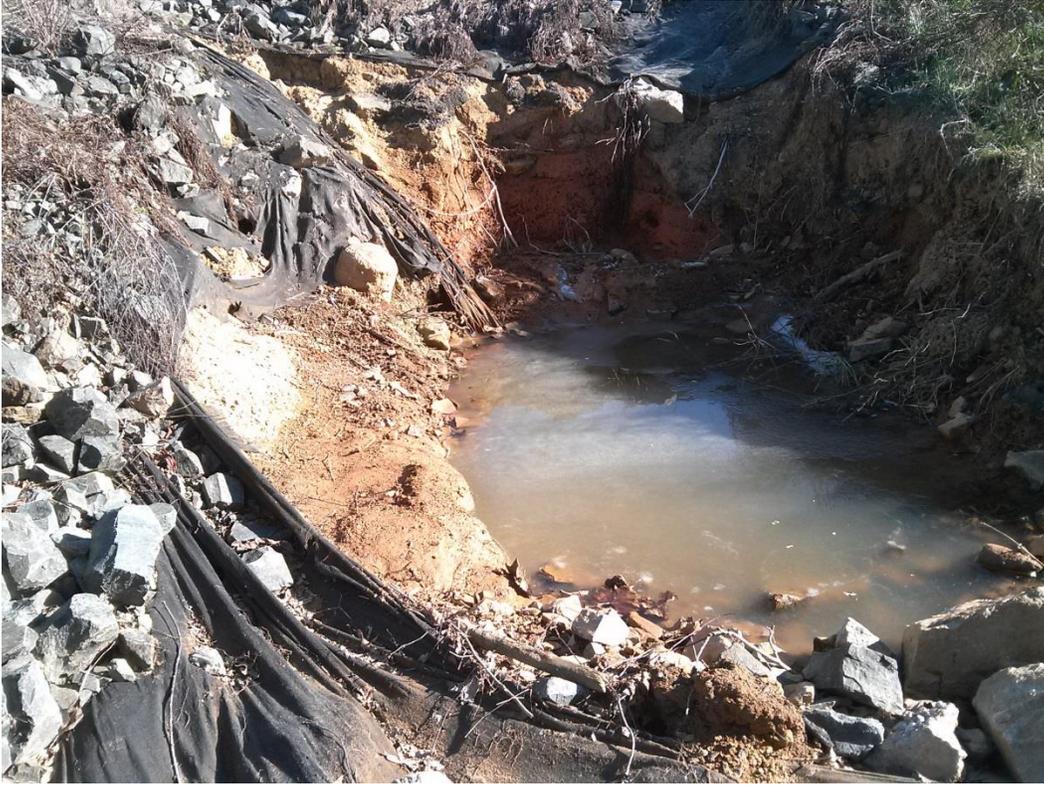
Close up view of emergency spillway failure

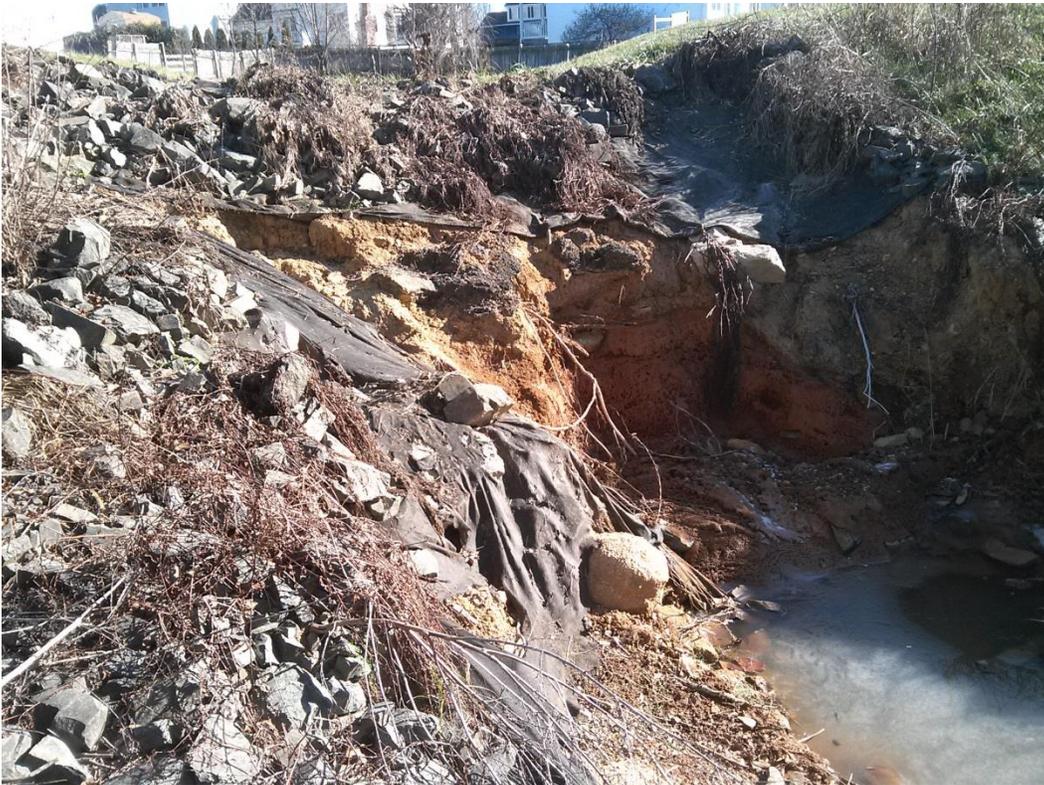
Close up view of emergency spillway failure

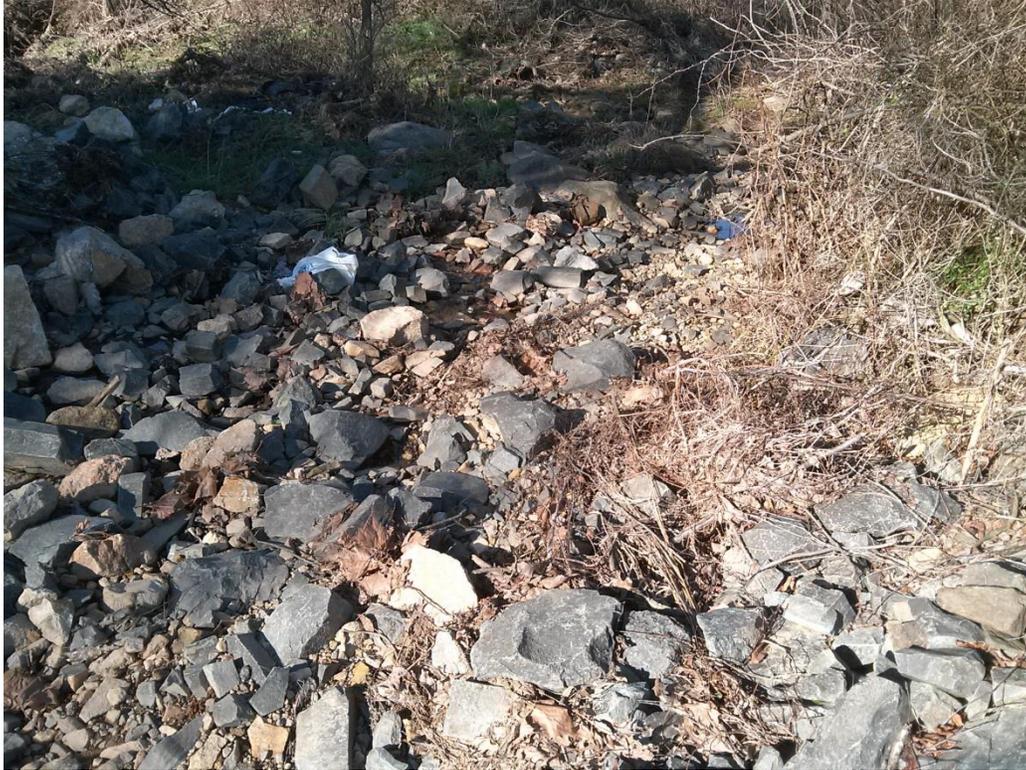
Riprap in stream channel below spillway

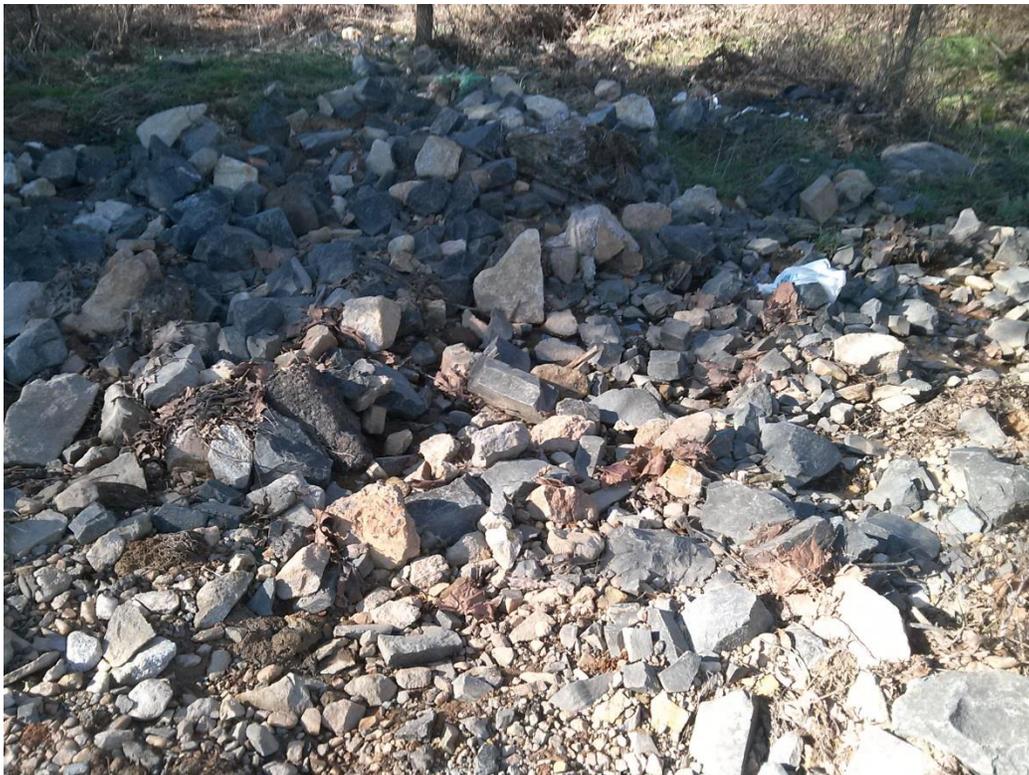
Riprap downstream in stream channel

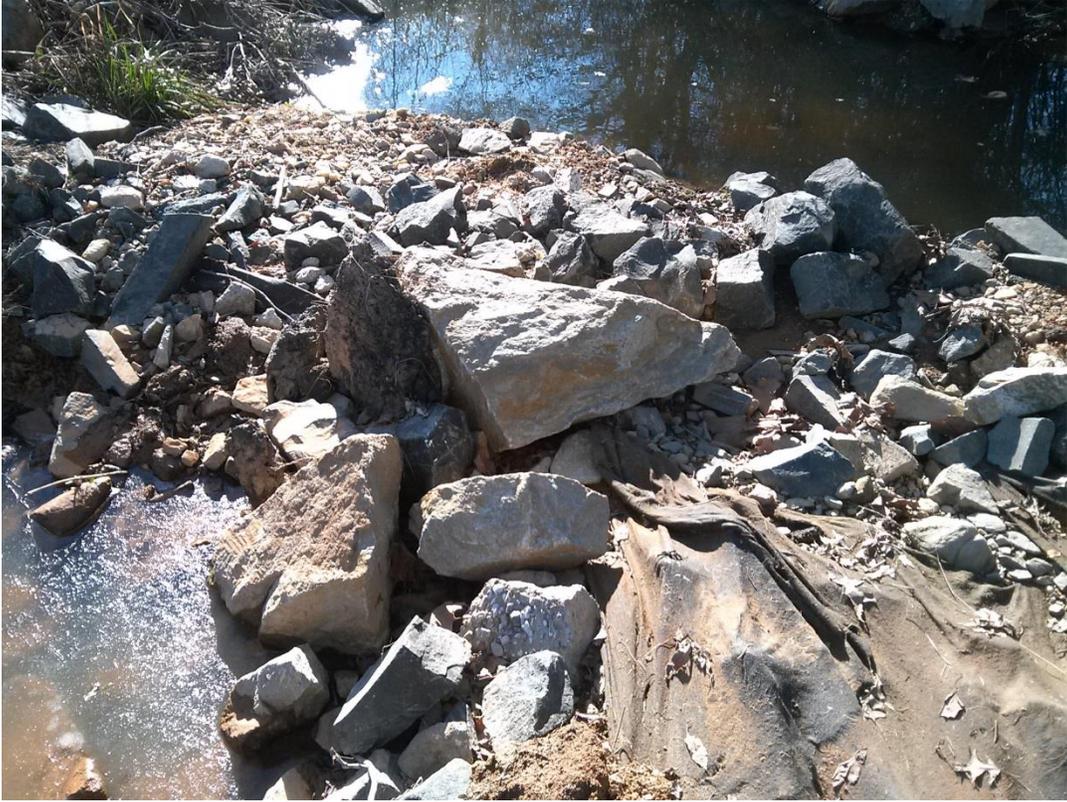
Riprap at base of spillway obstructing principal spillway outlet channel
